Block 2 Central  
1848 Boulevard  
Hunedoara  
Romania

Appendix 2 – Photos

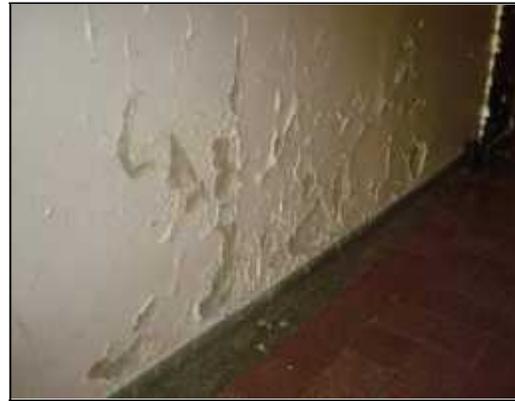
Interior view of damp penetration in the hallway
