Property 04 Block 2 Central
1848 Boulevard
Hunedoara
Romania

Property Description

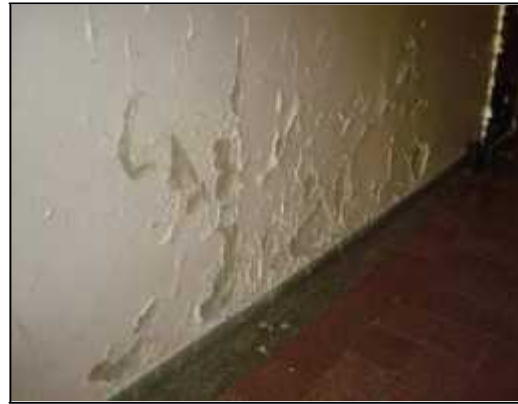
Interior view of damp penetration in the hallway
